AIRCRAFT GROUND-FLOTATION INVESTIGATION

PART XI - DATA REPORT ON TEST SECTION 10

TECHNICAL REPORT AFFDL-TR-66-43, PART XI

SEPTEMBER 1966

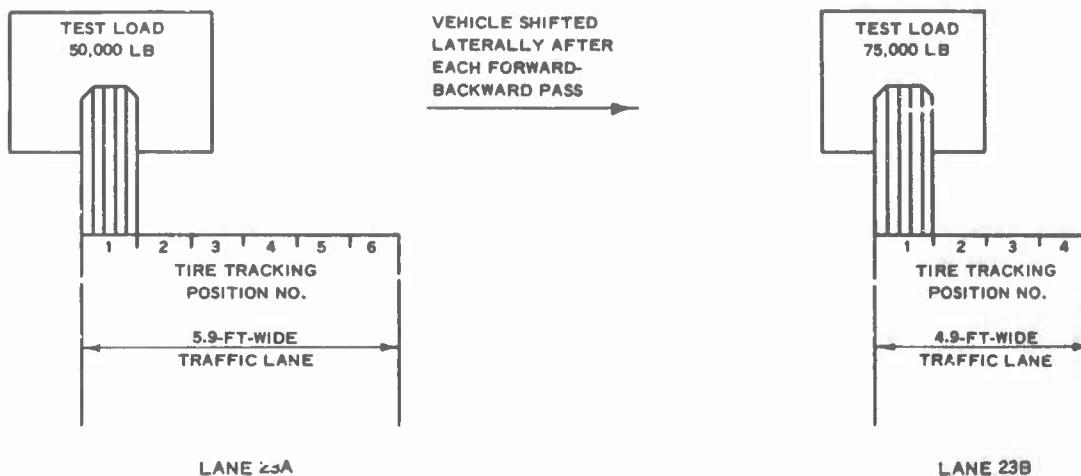
Figure 1. Application of traffic on Test Section 10

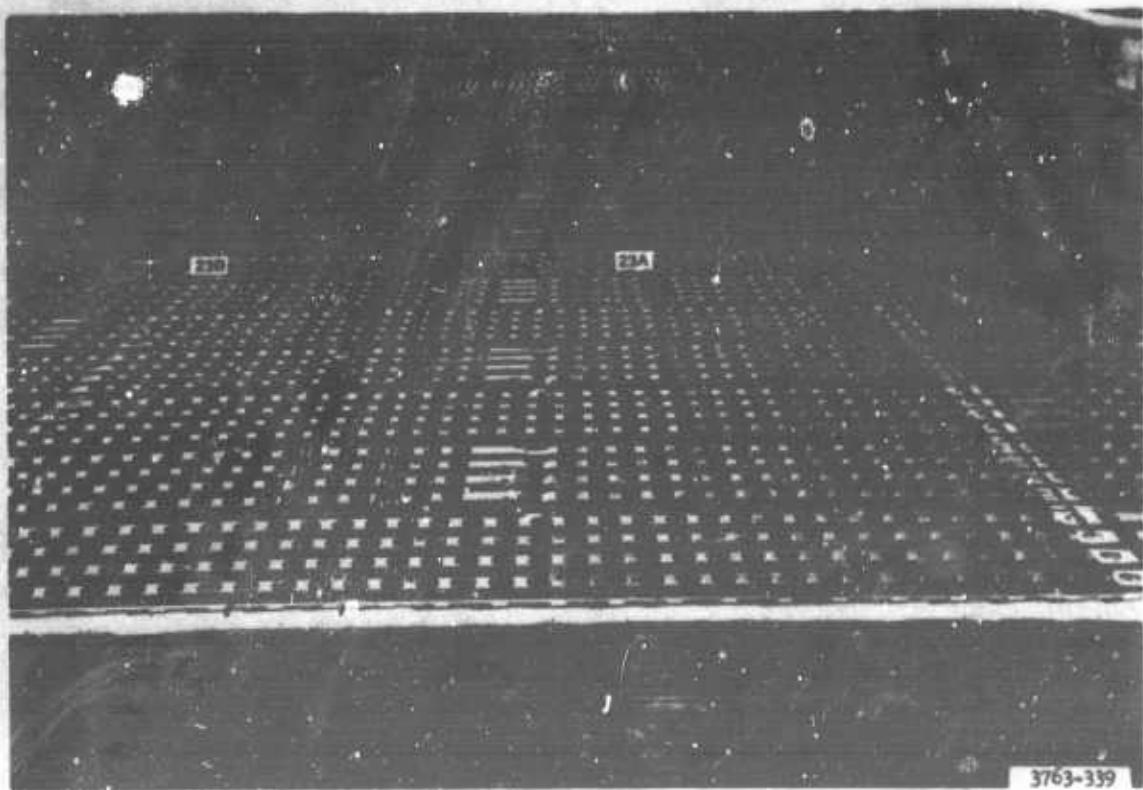
Item 2. Figure 5 shows item 2 prior to traffic. The item deformed rapidly under traffic and at 2 coverages was considered failed due to roughness (figure 6). The rated CBR for the item was 3.8.

Item 2. Figure 5 shows item 2 prior to traffic. The subgrade was severely deformed with the first pass of the load vehicle. The item was considered failed due to roughness after 2 passes (figure 8). The rated CBR for the item was 3.9.

Figure 5. Lanes 23A and 23B, item 2, prior to traffic

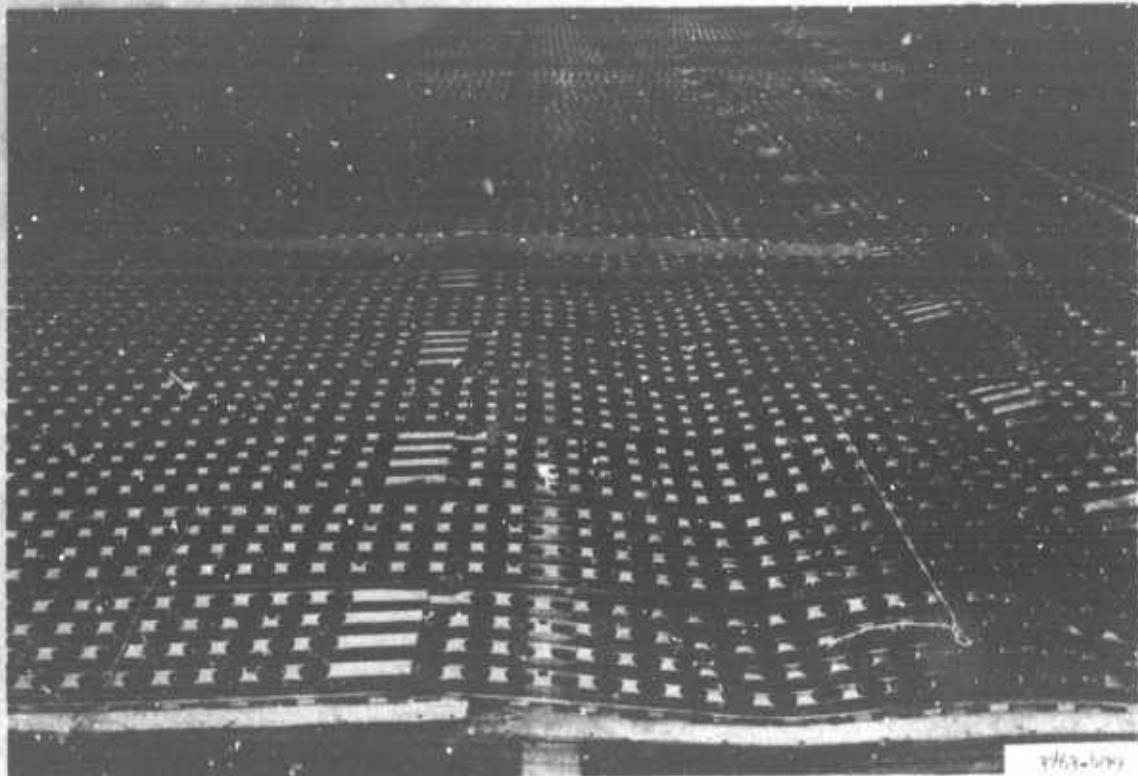
- a. Roughness. Table 1 shows maximum and average values of transverse differential deformation at 2 passes. The average measurement was 2.37 in. No measurements were made of longitudinal and diagonal differential deformations.
- b. Deformations, deflection, and rolling resistance. No measurements were made of cross-section and profile deformations, deflections, or rolling resistance.
- c. Mat breaks. No breaks occurred in the M8 mat with trafficking.

Figure 8. Lane 23B, item 2. Transverse straightedge shows roughness at 2 passes (failure)

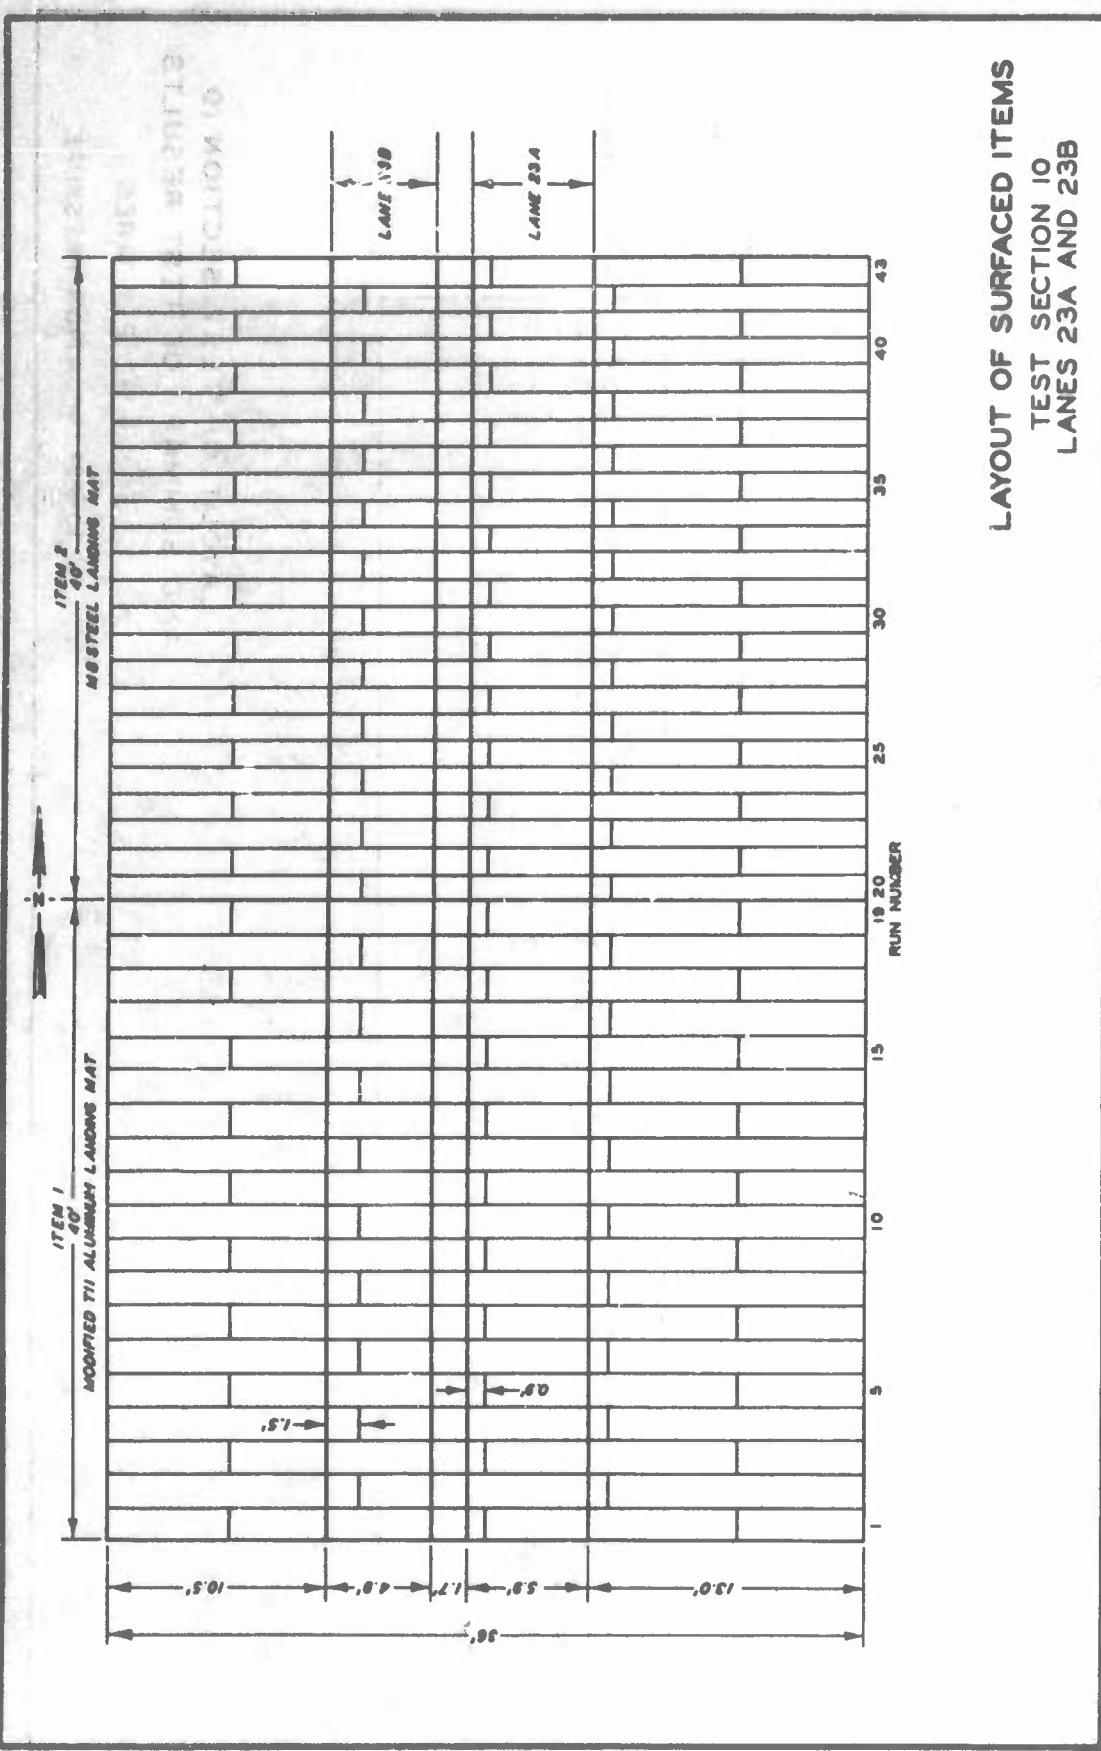
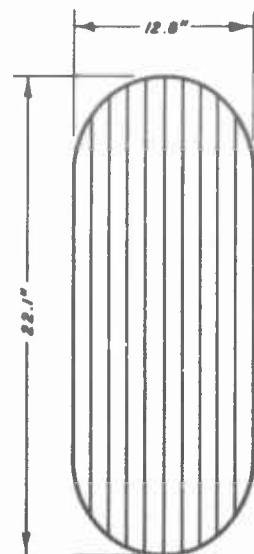
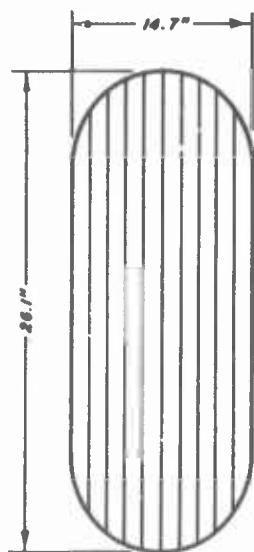
Figure 10

Two traffic lanes, each divided into two items, were constructed in the test section. Different subgrade strengths were obtained in the items (figure 9) by controlling the water content and compaction effort. Item 1 was surfaced with modified T11 aluminum landing mat and item 2 with M8 steel landing mat (figure 10). The landing mats used are described and illustrated in Part I.

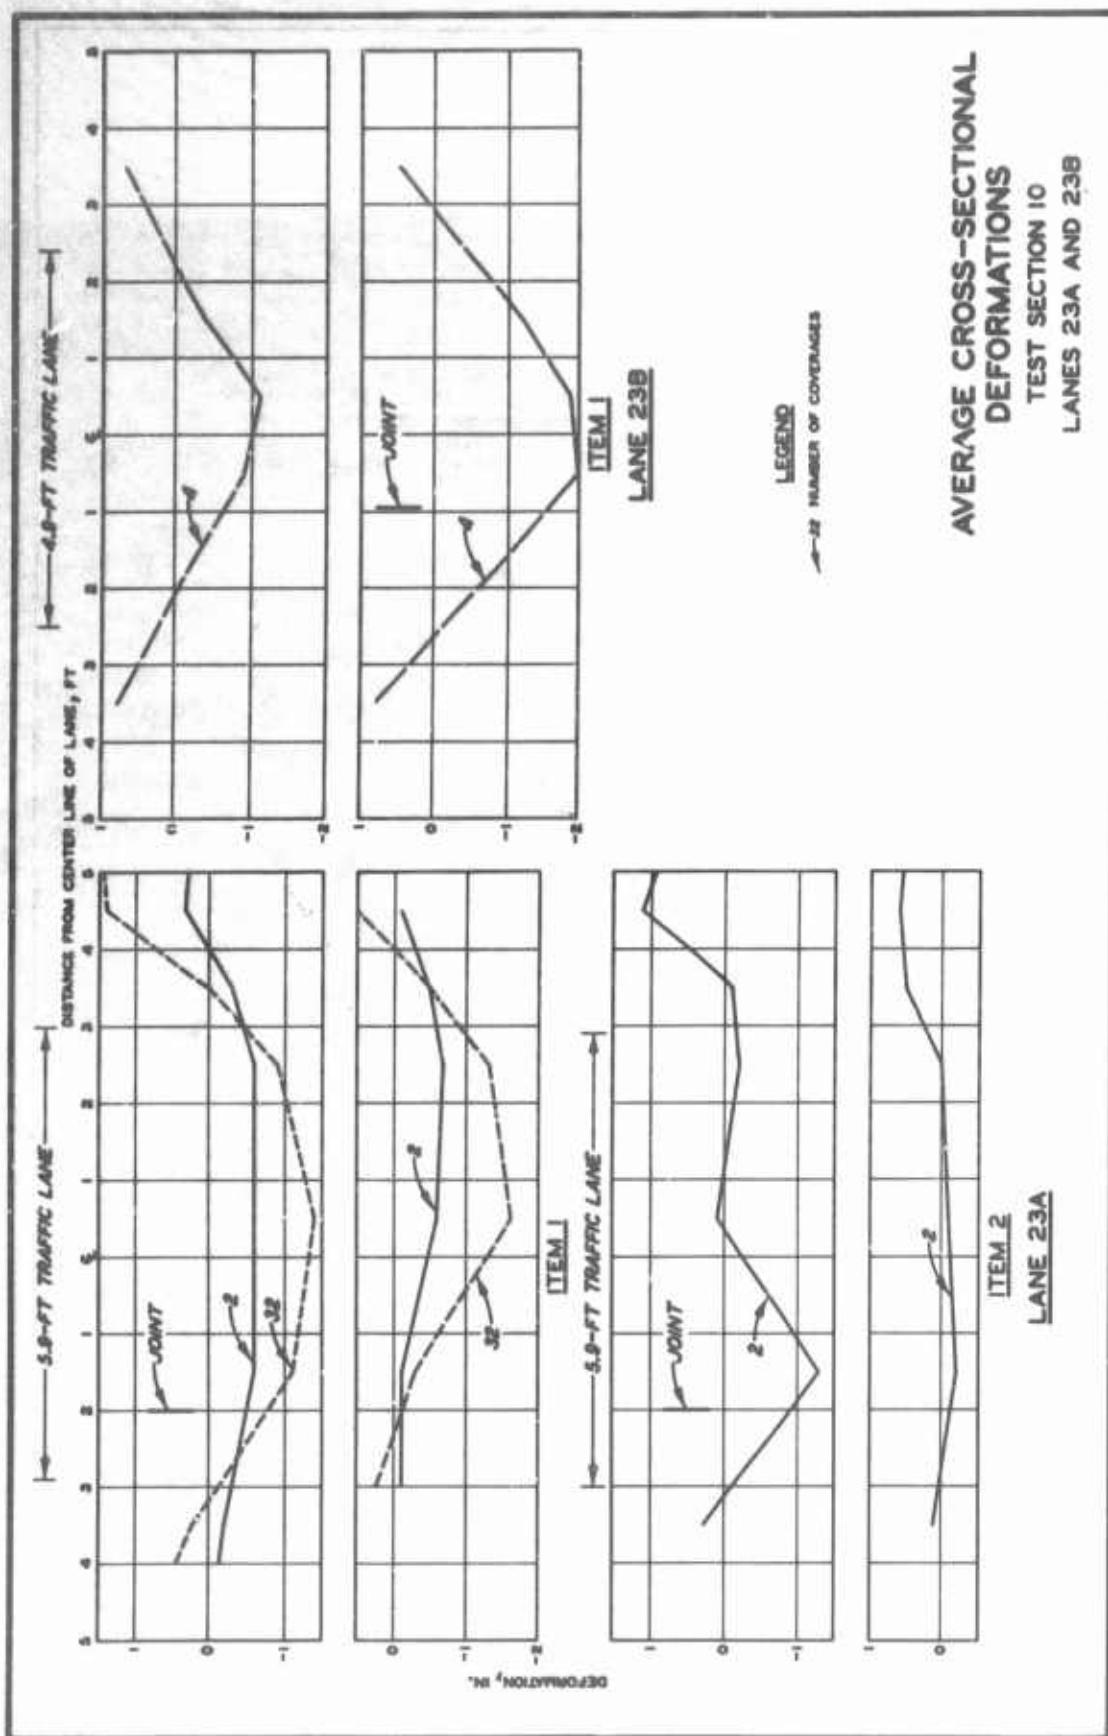
- b. Deformations. Figure 12 shows average cross-section deformations at 2 and 32 coverages for each of two typical mat runs. Figure 13 shows a profile plot of the item at the same coverage levels. Severe transverse differential deformations are evident and were the principal roughness factor contributing to failure.

- b. Deformations. Average cross-section deformations at 2 coverages for two typical mat runs are plotted in figure 12. A very significant factor in cross-section deformations was the mat uplift along both sides of the lane. Figure 13 shows the longitudinal irregularities that contributed to early failure of the item.

- b. Deformations. Figure 12 shows average cross-section deformations at 4 coverages for two typical mat runs. Mat uplift at the lane edges contributed to the cross-section deformation. No profile deformation data were obtained on this item.

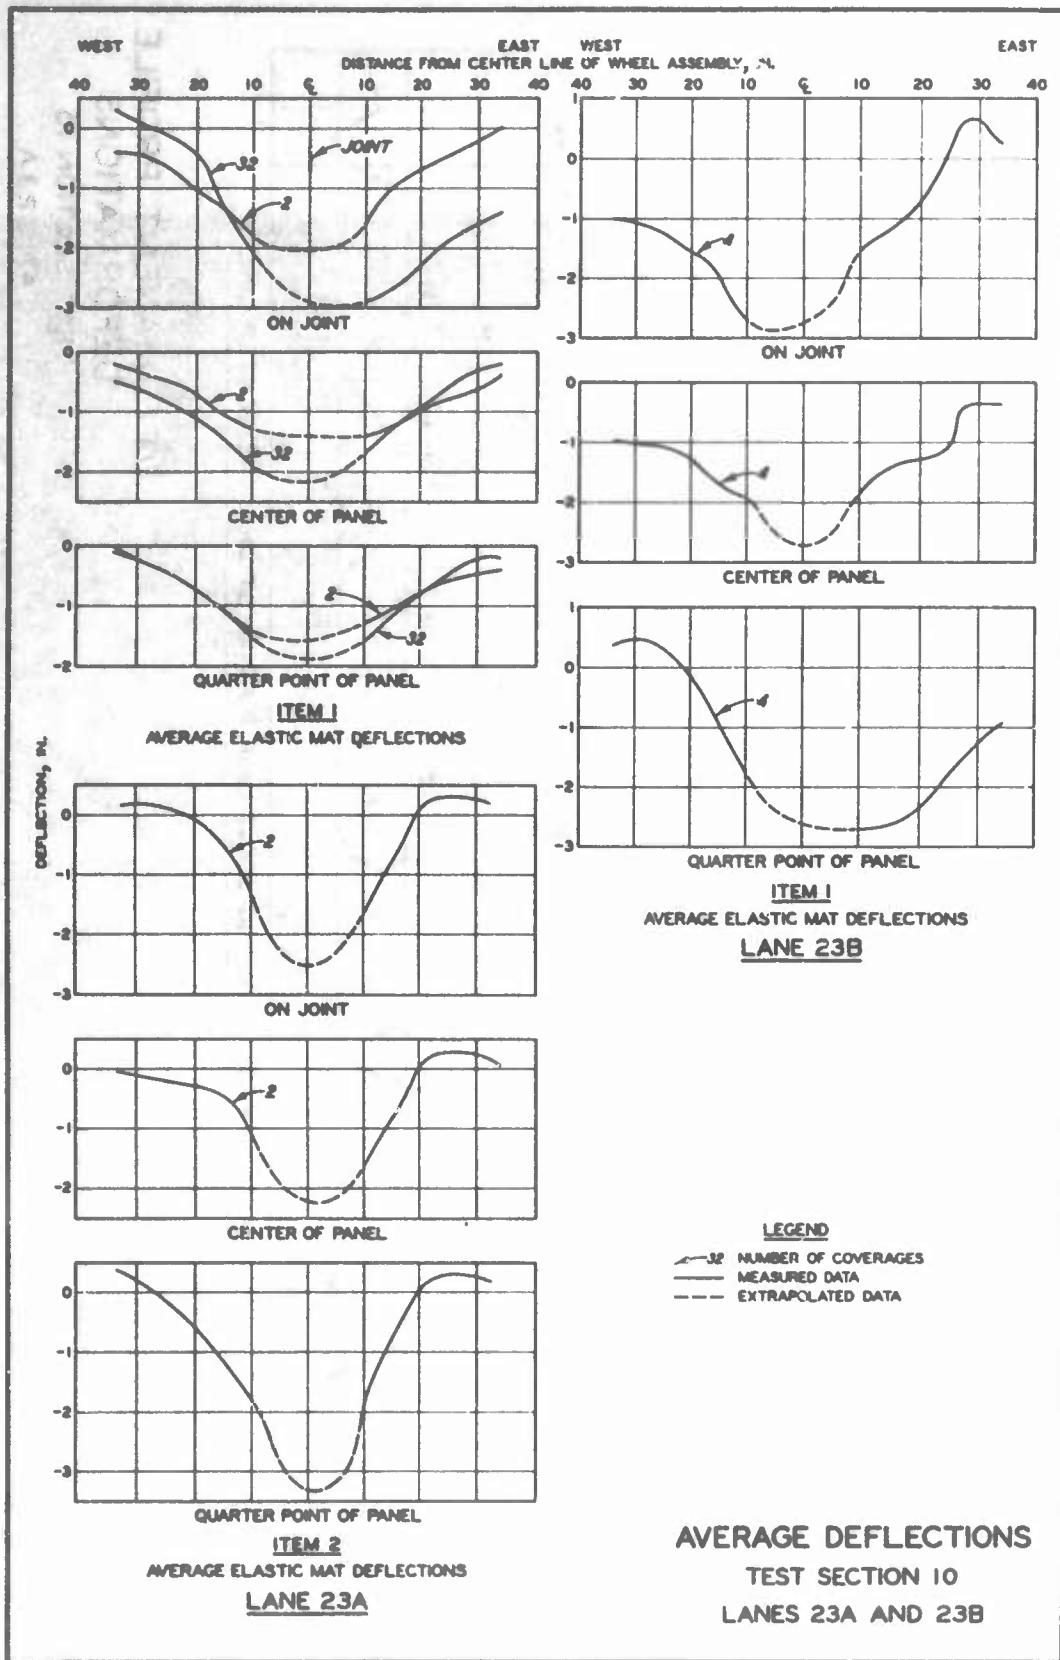
Figure 14

- c. Deflection. Average elastic mat deflections under static load of the load wheel assembly for three positions of the assembly relative to mat end joints are plotted in figure 14. Deflection at 32 coverages was greatest for each position. Elastic soil deflection at failure was 1.6 in.

- c. Deflection. Average elastic mat deflections under static load of the wheel assembly are plotted in figure 14 for three positions of the assembly relative to mat end joints.

- c. Deflection. Average elastic mat deflections under static load of the wheel assembly for three positions of the assembly relative to mat end joints are plotted in figure 14. Only small differences in deflection occurred for the different positions.
